**PRELIMINARY ASSESSMENT EQUIVALENT REPORT
DAYTON ELECTROPLATE, INC., SITE
DAYTON, MONTGOMERY COUNTY, OHIO
TDD: S05-9611-013
PAN: 6B1308SI**

December 9, 1997

SITE ASSESSMENT REPORT
FOR
THE DAYTON ELECTROPLATE, INC., SITE
DAYTON, MONTGOMERY COUNTY, OHIO
TDD: S05-9609-018
PAN: 6P1801SI
DOCUMENT CONTROL NUMBER: START-05-23-05019

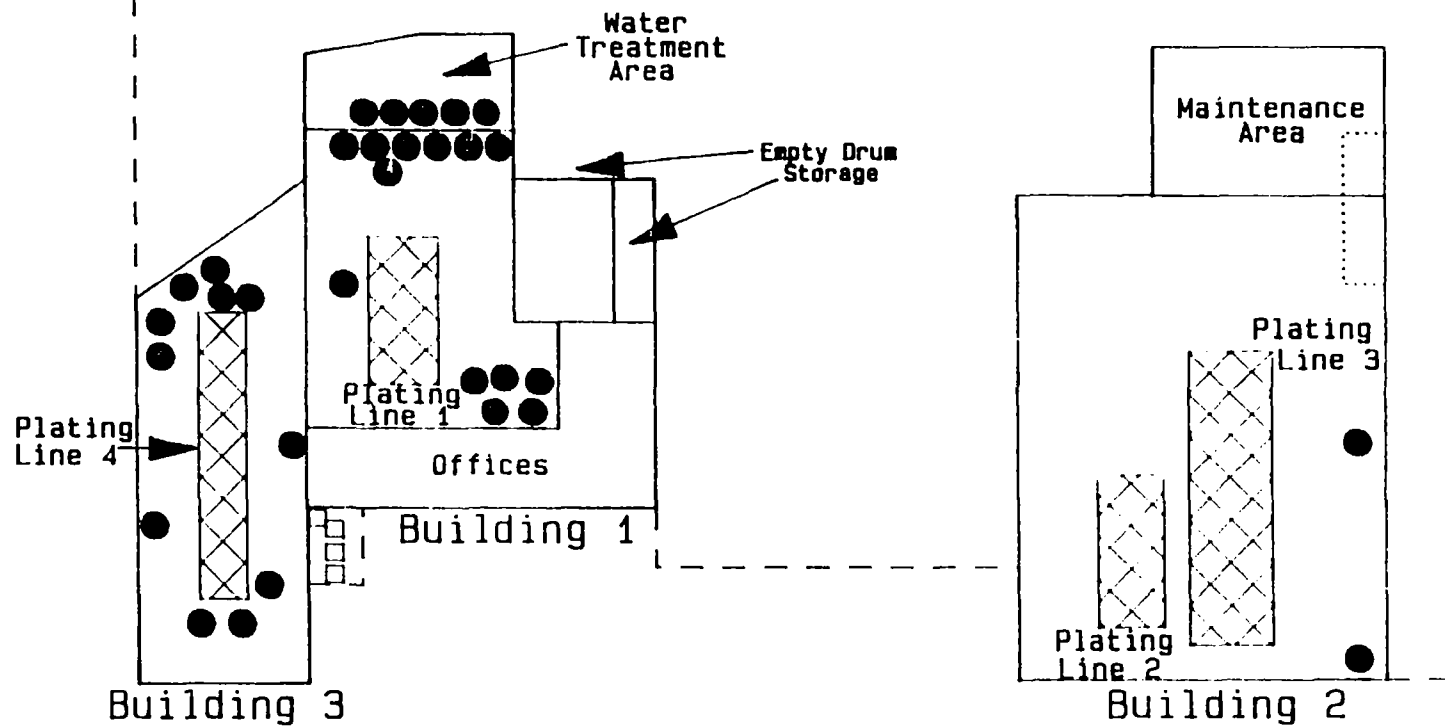
TITLE:	Site Features Map	FIGURE #	2
SITE NAME:	Dayton Electroplate, Inc.	PAN #	6P1801SI
CITY:	Dayton	STATE:	Ohio
SOURCE:	Ecology & Environment, Inc.	SCALE:	Not To Scale
		DATE:	1996
		REVISED:	1996

A small area adjacent to Buildings 1 and 3 is enclosed by a separate chain-link fence. Three transformers were observed on a concrete pad in this fenced area. A fourth, smaller transformer was observed on an electrical pole, also within the fenced area. It is not known whether oils in any of the four transformers contain polychlorinated biphenyls.

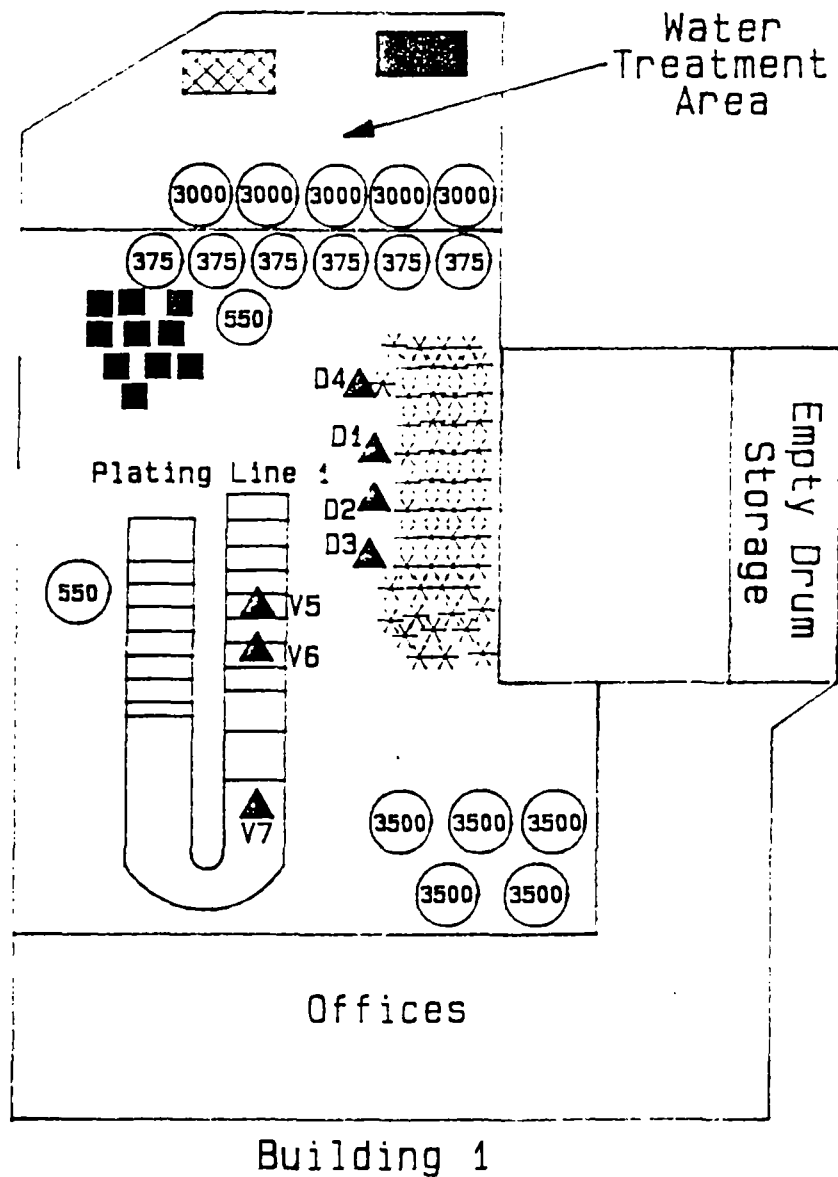
TITLE	Building 1 Sample Location Map	FIGURE	3
SITE	Dayton Electroplate, Inc.	SCALE	Not To Scale
CITY	Dayton	STATE	Ohio
SOURCE	Ecology and Environment Inc.	PAN	6P1801SI
		DATE	1996
		REVISED

Approximately 70 full 55-gallon drums were observed in Building 1 along the west wall of the main room. Drums of unused products, stacked two drums high, were stored on pallets along the wall. The drums were staged by chemical name, based on small signs located on the wall. However, drums of acids, such as nitric (2 drums), sulfuric (8 drums), and hydrochloric (20 drums), were observed stored adjacent to drums of basic materials, such as sodium hydroxide (16 drums) and sodium hypochlorite (12 drums). A list of drums and containers inventoried by START during the site assessment, separated by building and area, is included as Appendix B.
